# REPORT OF THE SAFOD ENGINEERING SUBCOMMITTEE OF THE ADVISORY COMMITTEE FOR GEOSCIENCES, MARCH 30, 2011

## A. Introduction

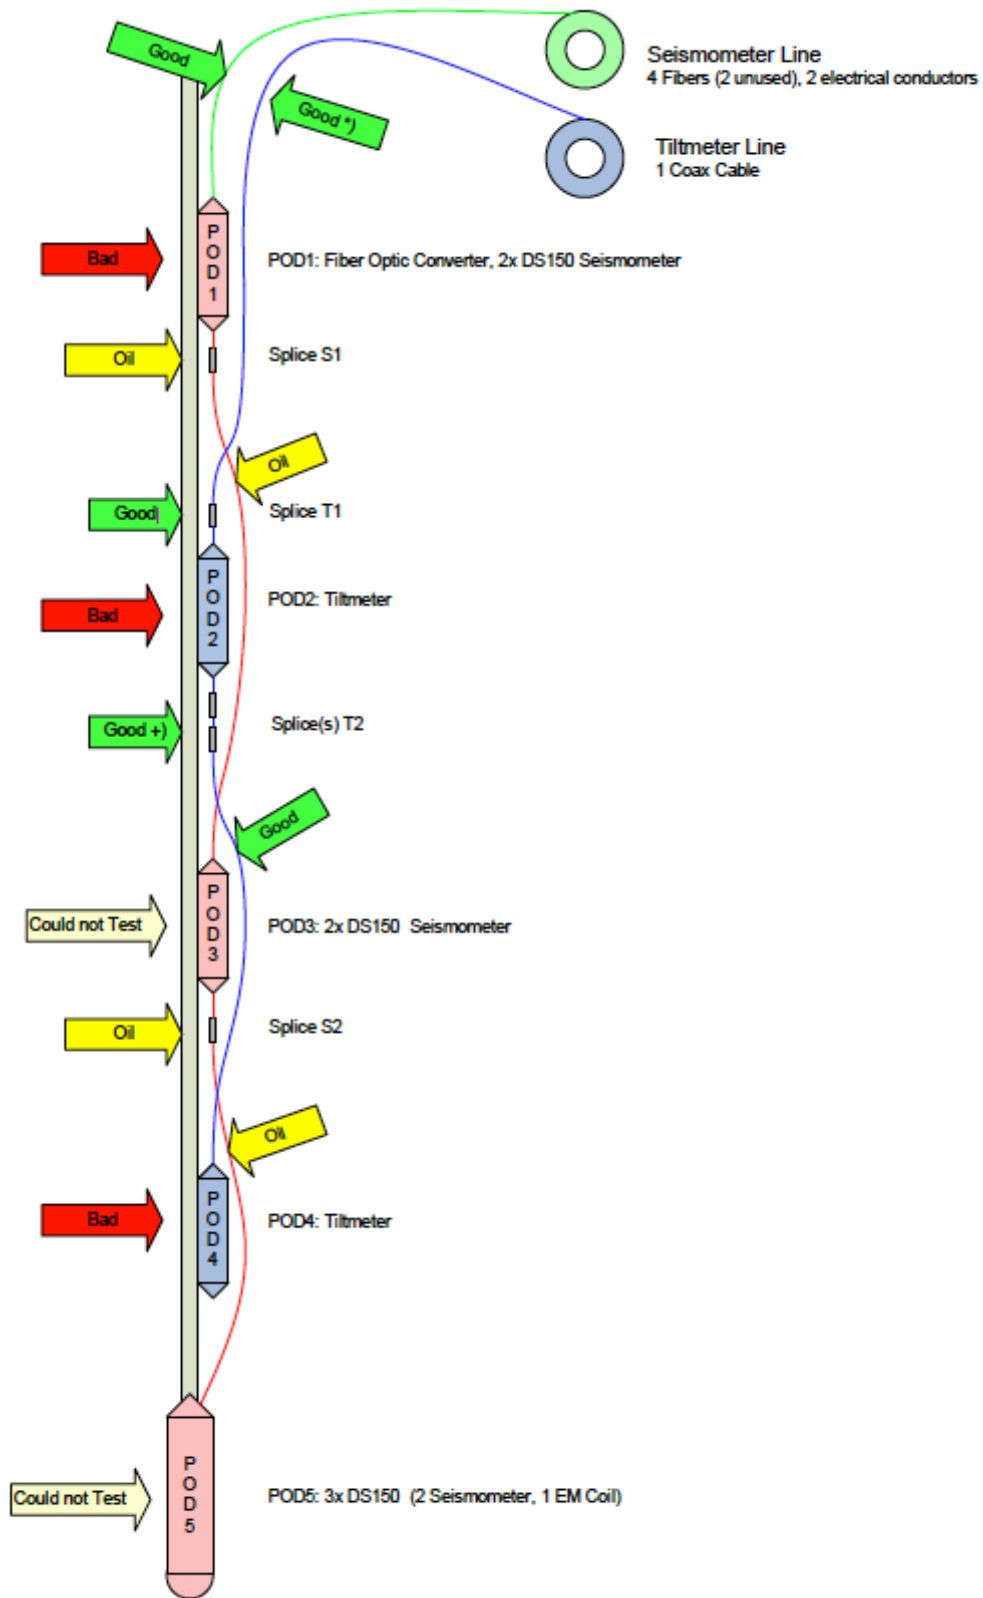
Figure 3 SAFOD DIP Showing the Two Separate Control Lines

- A broken wire was found in Splice S2 (see Figure 3). It is not clear if the break occurred before or during disassembly.

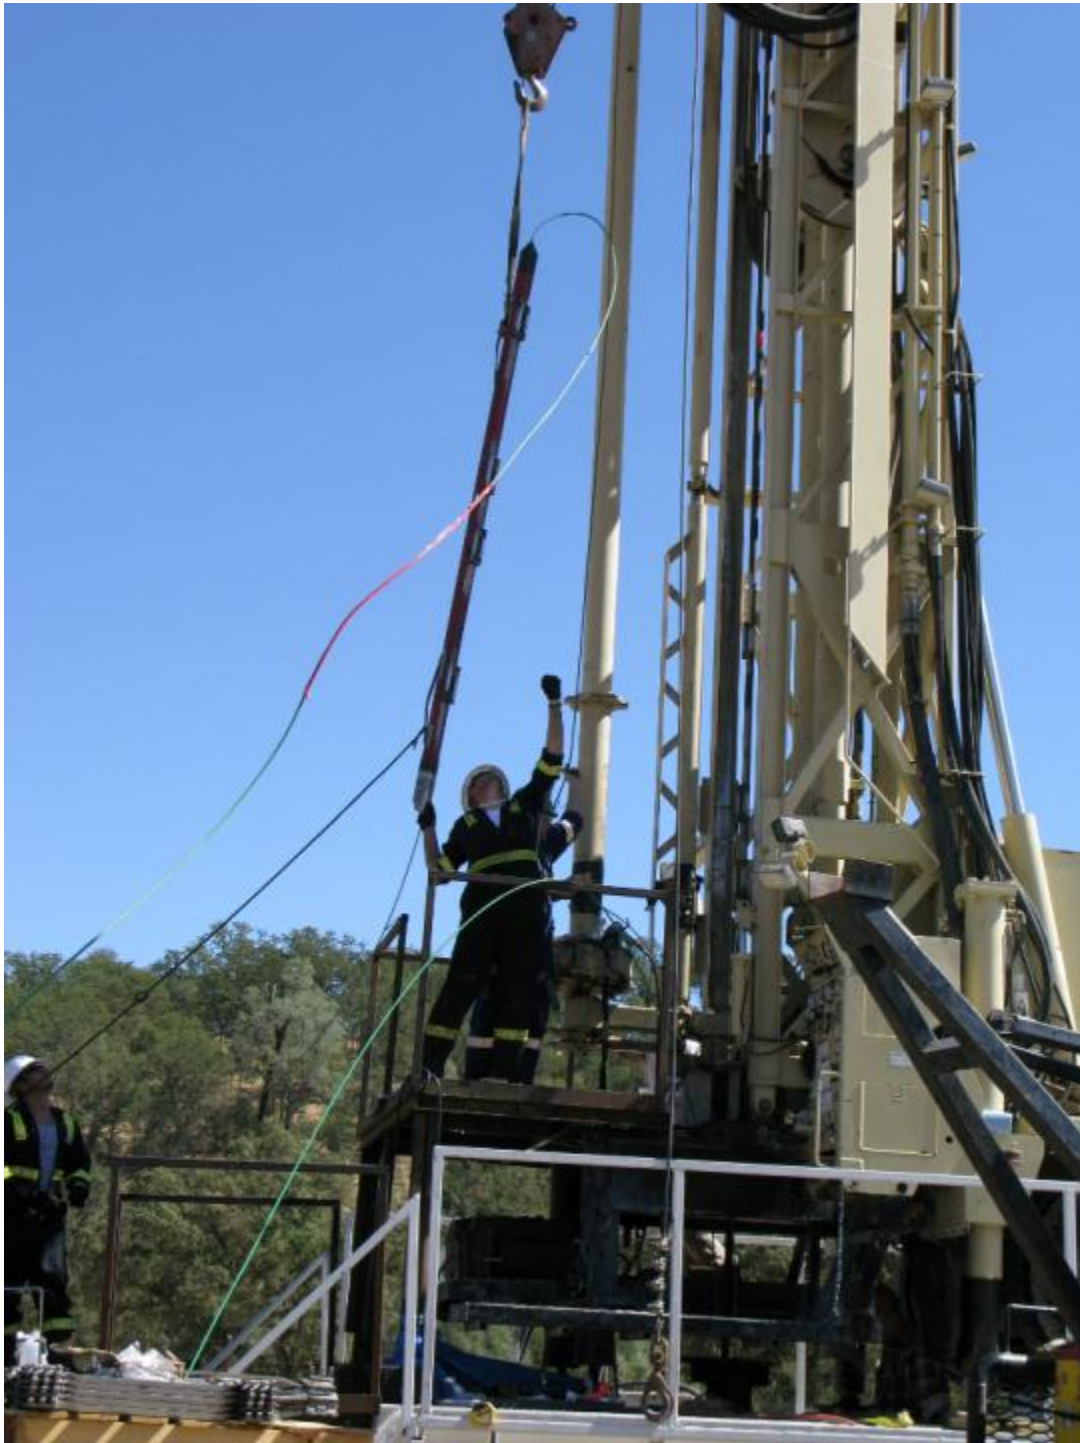
Figure 4 Installing a Pod - Control Lines are Clearly Visible

Lastly, the committee noted that the metal-metal contact surface in a Swaged coupling is small and may be easily compromised during insertion into the wellbore, which is a rather rough handling process (see for example Figure 4). In addition to rough handling, each swaged connection can be compromised by dirt or debris between the cone and seat of each connection. It was not clear to the committee to what extent the attention to detail, as noted above, was an essential theme of the fabrication and installation process. The committee did note that the clamping of the ¼ inch tubing to the EUE tubing was a good idea, and had potentially reduced the chances of additional failures.

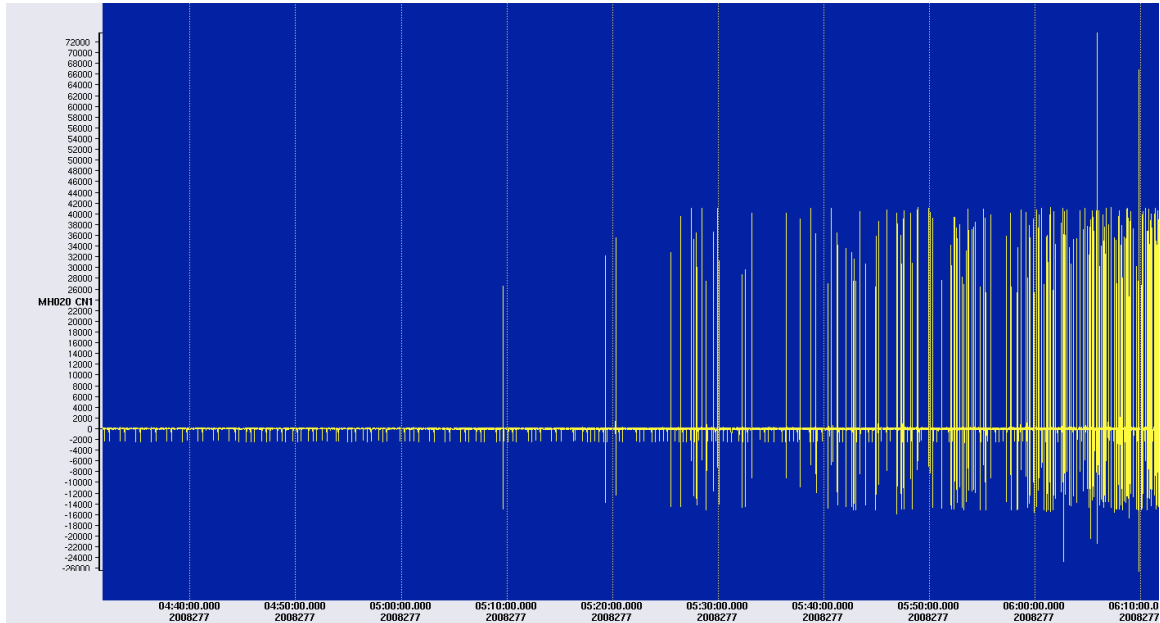
Figure 6 Spikes Developing in Seismic Data

1. The tiltmeter in Pod 4 lost contact with the surface before the DIP hit bottom. The failure was probably due to an open circuit that occurred during installation.
2. The tiltmeter in Pod 2 began to have problems shortly after deployment and stopped working two weeks later. It was found to be partially filled with oil during disassembly, suggesting a leak at one of the O-ring seals.
3. The seismic array arrived on the bottom fully functional, but problems began after several days. A perplexing pattern of noise developed with a 24-hour cycle (possibly due to ground loops).

4. Communication problems developed shortly thereafter.
5. Approximately 10 days after deployment, all communication was lost with the exception of the instrument in Pod 1. Several days later the last instrument went into a spasm of dropouts, spikes (Figure 6) and reboots. Dropouts can be indicative of cable issues due to leakage or to premature electronic component failure.

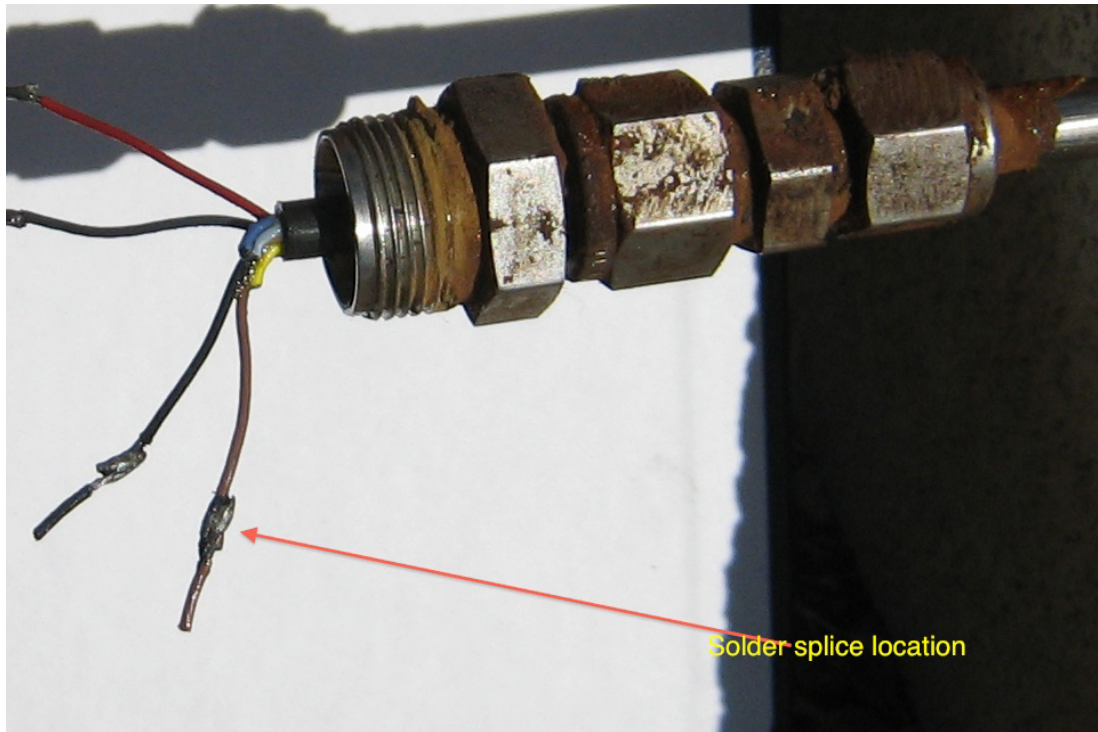
Figure 8 Poorly Soldered Splices

- The Mobil 1 had migrated between Pods through the ¼ inch tubing, indicating that the cable heads were probably compromised in some cases.
- Electrical splices between Pods were poorly done. The exposed ends of the wires were placed parallel to one another and soldered with no mechanical connection (Figure 8). Individual splices within their protective steel tubes were not staggered. A broken brown wire was found to have occurred near splice S2 between Pods 3 and 5. Insulation materials around the soldered connections had badly deteriorated in many cases. This may have allowed conductive fluid that migrated along the ¼ inch tubing and into the splices to create short-circuits between individual splices.
