Arecibo Observatory William E. Gordon Radio Telescope (305-Meter Radio Telescope) Collapse Emergency Cleanup Update

December 2021

June to December 2021

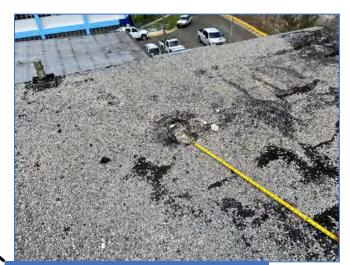
No changes or updates since last meeting. Minor roof damage was previously discussed.

Operations Building (Building 1) *After Minor Roof Damage*

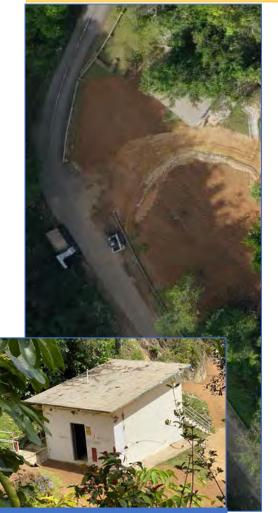
Cable Car Building (Building 5) *After* Damaged material removed from retaining wall and temporary concrete blocks installed since last meeting. Removal of front awning (nonsignificant element) was previously discussed. Blocks to temporarily remain in place.

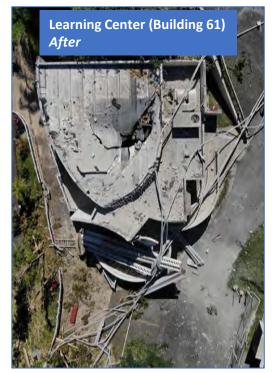
Learning Center (Building 61) After Temporary Roof

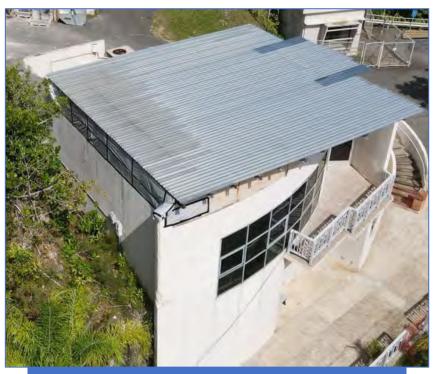
Weatherproofing installed to protect temporary wall under temporary roof. Temporary roof was previously discussed.

Learning Center (Building 61) After Temporary Weatherproofing, August 25, 2021

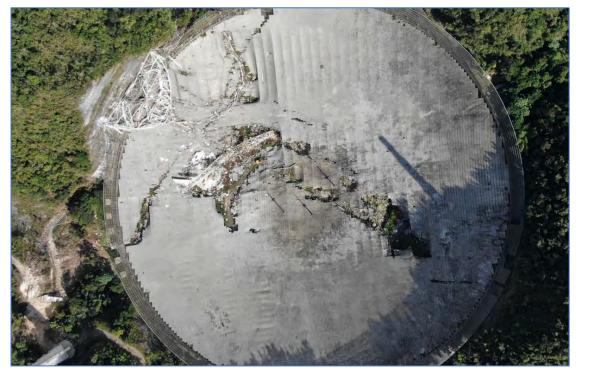
Reflector Area after collapse (left) and during clean-up (bottom right). Additional panels identified indicated in red with panel amount noted. Example of damaged panels (top right). Cleanup identified additional damaged panels that required mapping and removal. Reflector area damage was previously discussed.

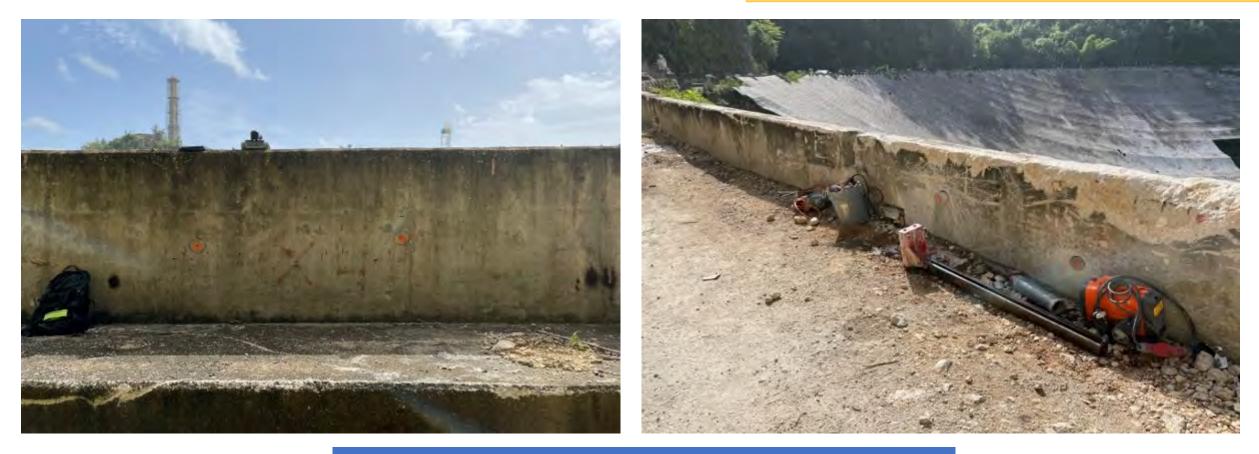
Cleanup identified additional damaged segments of the rim wall for removal and repair. Repairs made in-kind in compliance with Preservation Principles and Management Plan.

William E. Gordon (305-meter) Radio Telescope – Rim Wall – 9 concrete cores taken from rim wall for testing. Cores are red circled areas.

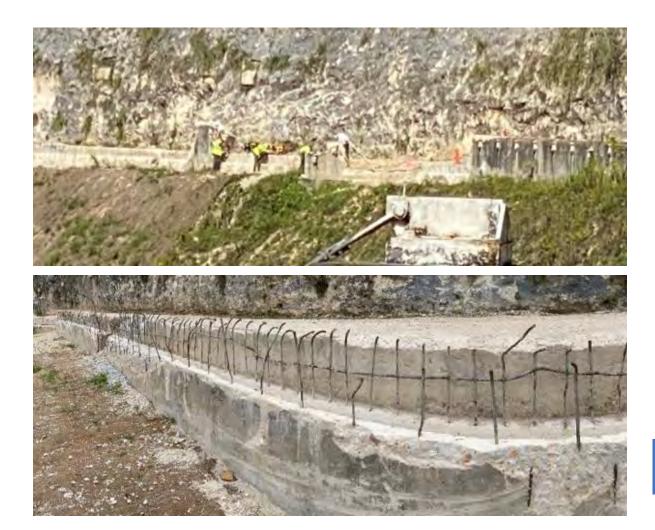
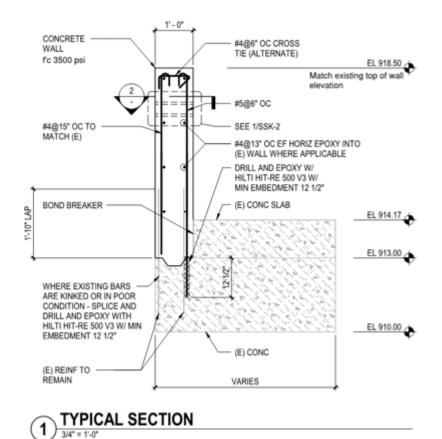
Cleanup identified damaged segments of the rim wall for debris removal and repair. The repaired wall retains the same material and dimension (height and width) as the original wall.

Rim Wall – Segment for repair (top and bottom at left) and repair detail (above right)

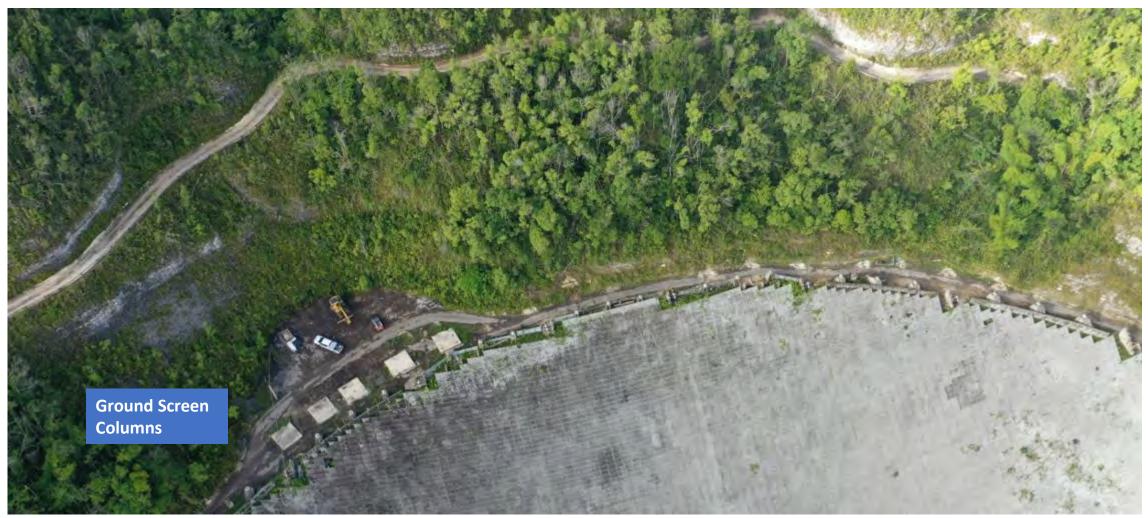
Cleanup identified damaged ground screen columns for removal as part of the rim wall (removed due to structural concerns).

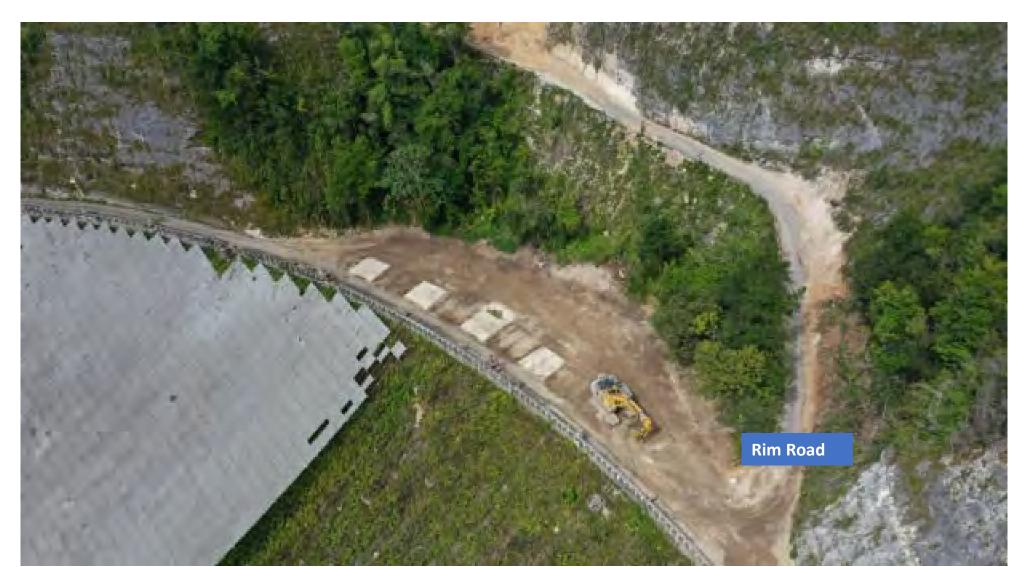
Cleanup regraded rim road after debris was removed.

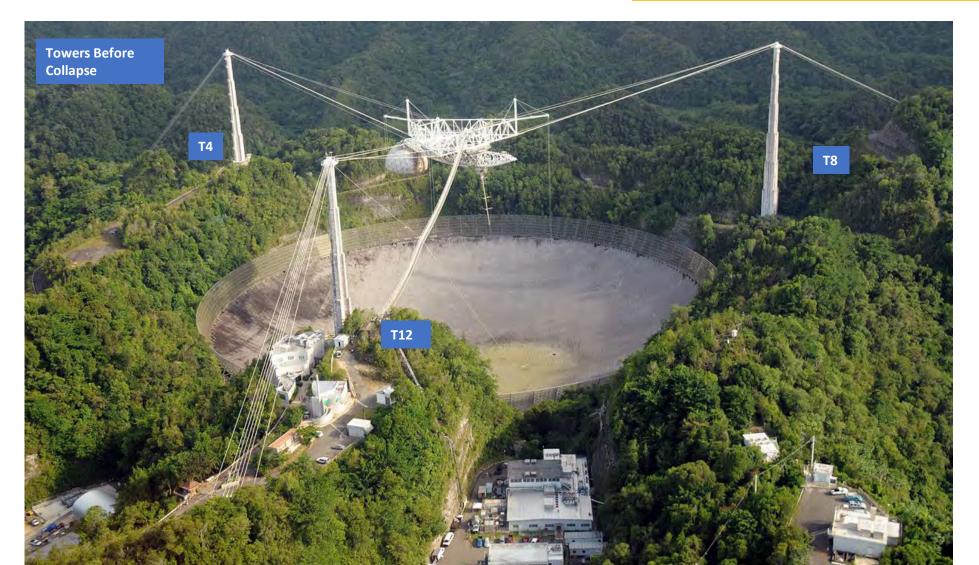
Cleanup progressed with scaffolding, debris removal, test cores, concrete repair, and waterproof membrane applied to top of exposed towers.

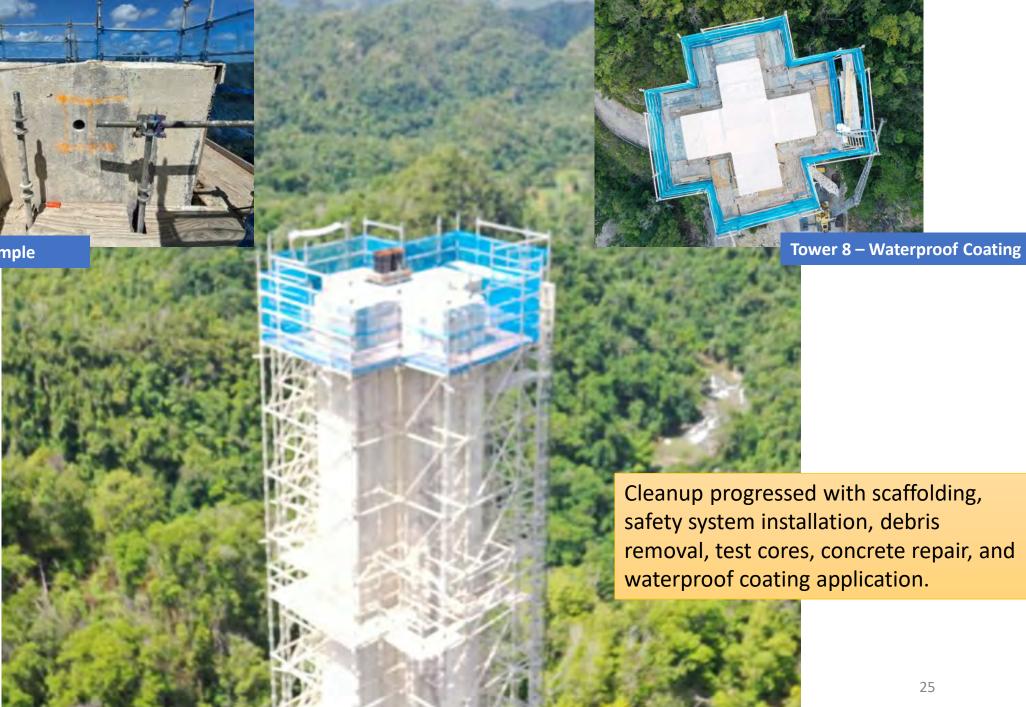
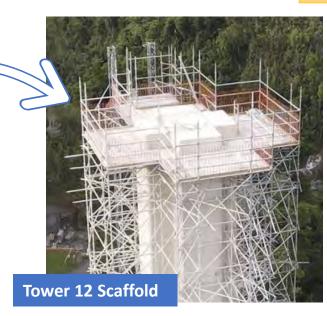
Cleanup progressed with scaffolding, safety system installation, debris removal, test cores, concrete repair, and waterproof coating application.

Tower 12 required the surgical demolition of debris to minimize further damage to the remaining original structure.

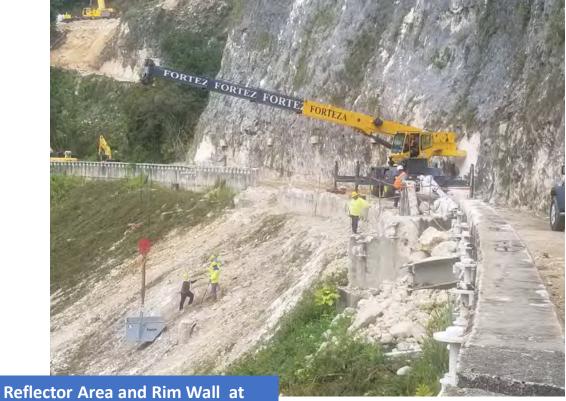
Cleanup involved soil removal and erosion control measures.

Reflector Area and Rim Wall Platform Impact Area

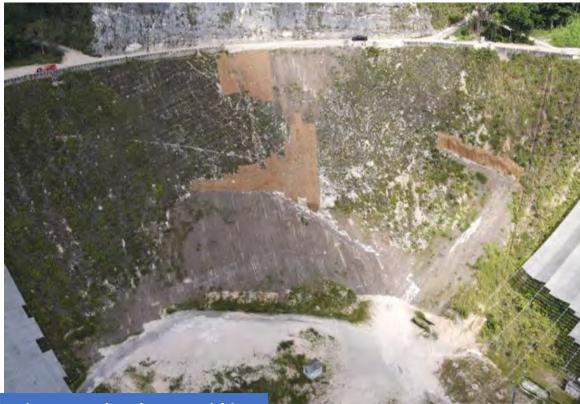
Erosion control underway within the Reflector Area

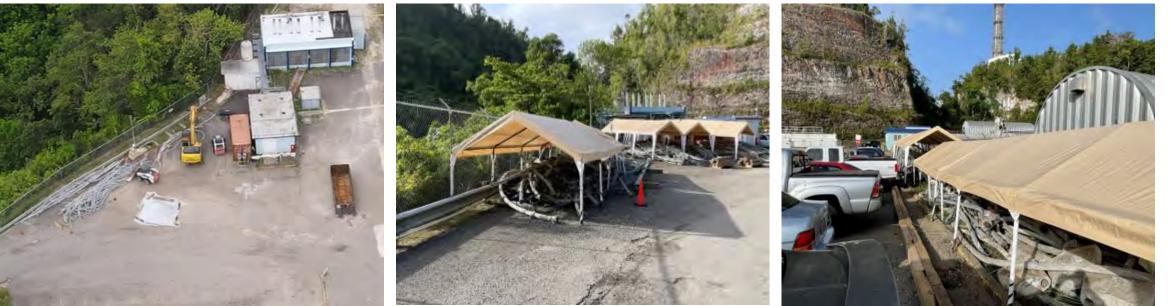
Cleanup gathered 114 bundles equaling 35 miles of cable. Cable segments were removed, processed, and stored.

Cable processing underway (top and bottom left). Tented cable storage on parking lot (above left and right)

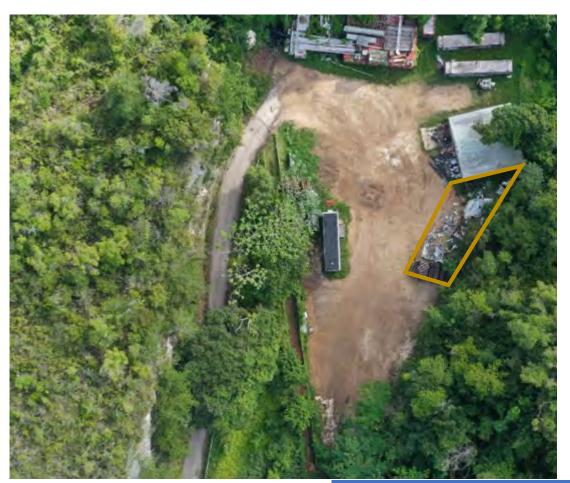
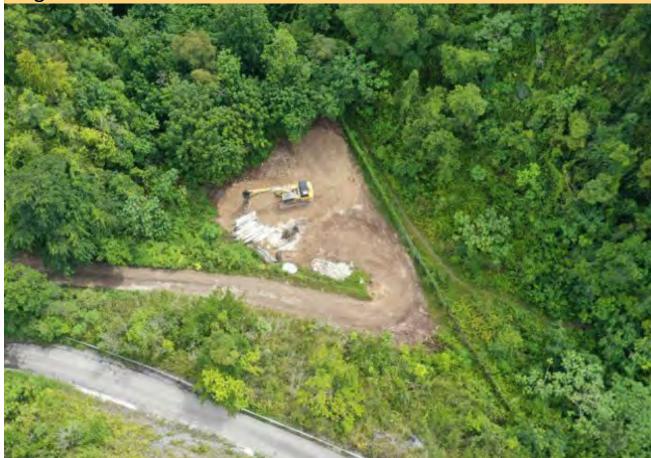
Cleanup required processing of metals within the Storage Yard (not within historic district). Important objects identified by the Salvage Survey Committee were sorted and stored separately. Crushed concrete was placed, and the scrap yard was regraded.

Scrap staging yard and temporary salvage area is marked off and shown with yellow outline (left). Processing area near Tower 4 in June 2021 (right)
