Protected Species Mitigation and Monitoring Report

Marine Geophysical (Seismic) Survey
North Pacific Ocean

Gulf of Alaska
08 June 2019 – 24 June 2019

R/V Marcus G. Langseth

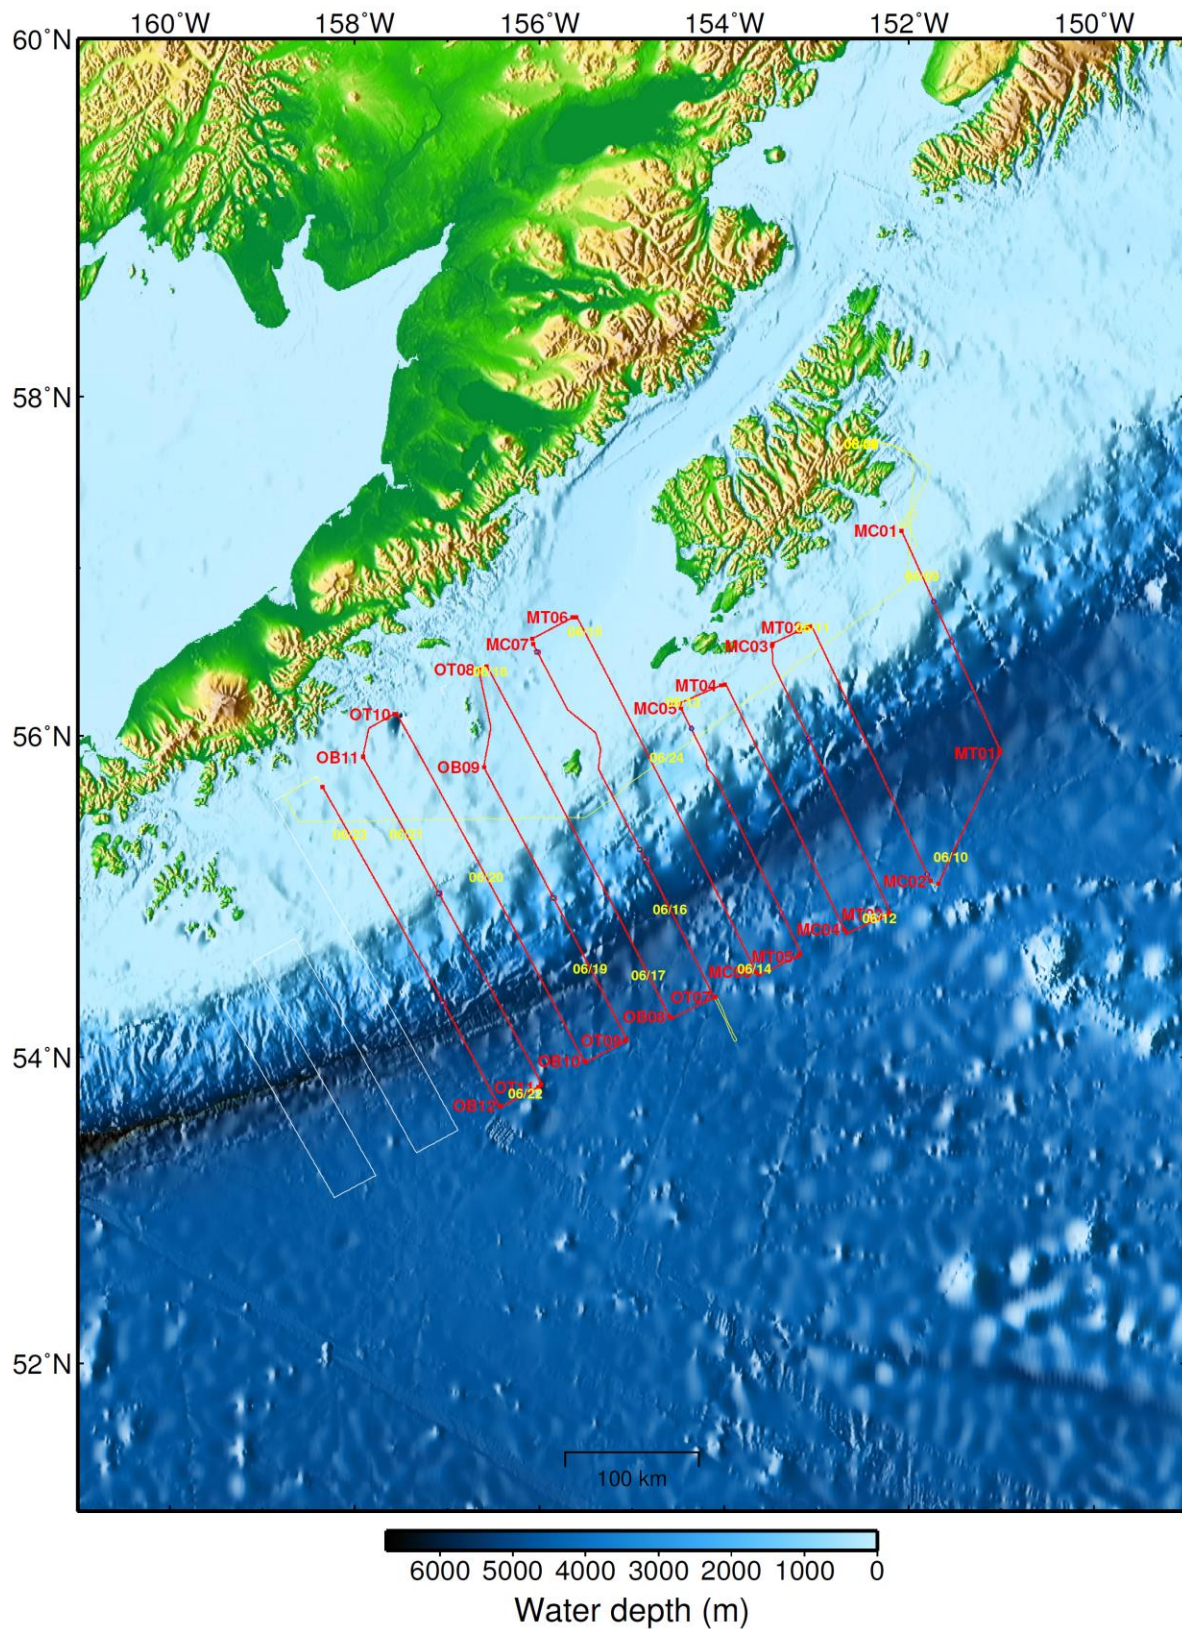
Figure 1. Location and survey lines of the Gulf of Alaska marine geophysical survey.

Seismic acquisition was conducted from 08 to 23 June 2019. There were 23 survey lines acquired during the program, including 13 multi-channel seismic (MCS) streamer lines and ten ocean bottom seismometer (OBS) lines, totaling 3,185 kilometers. Data acquisition along several planned survey lines could not be completed within the scheduled survey time frame (Figure 1).

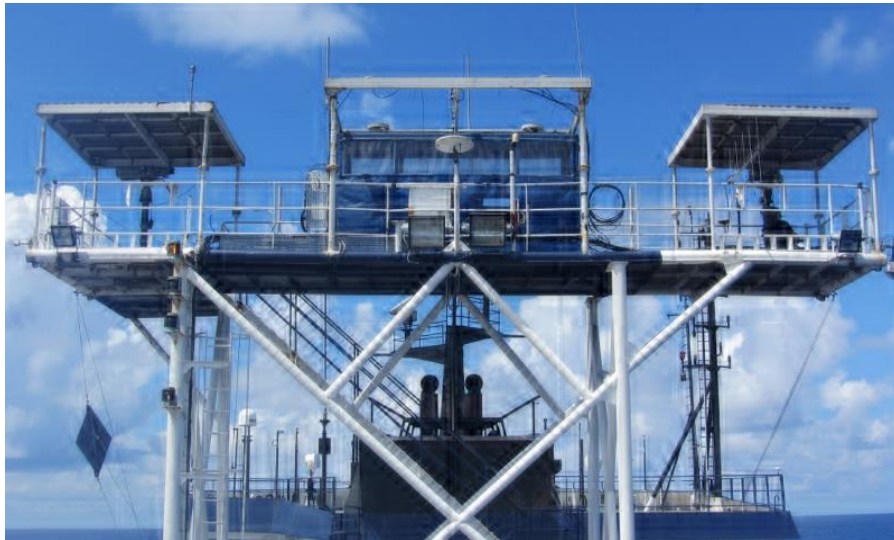
Figure 2. Protected Species Observer observation tower with mounted big-eye binoculars, as seen from the stern of the vessel.

The PSO tower was equipped with Fujinon 7x50 and Steiner Marine 7x50 binoculars, as well as two mounted 25x150 Big-eye binoculars, and a D-300-2MS Night Optics USA, Inc. monocular (for visual clearance and monitoring of night time ramp-ups). In addition, a Butler Creek PVS-7-night vision monocular was secured in the bridge and could be requested for use by the PSOs as needed. Inside the tarpaulin tent located in the middle of the platform was a laptop for data collection, and a telephone for communication with the PAM station, bridge, and main lab. There was also a monitor that displayed current information about the vessel (e.g. position, speed, heading, etc.), sea conditions (e.g. water depth, sea temperature, etc.), weather (e.g. wind speed and direction, air temperature, etc.), and source activity (e.g. survey line number, total number of active elements, volume, etc.). Environmental conditions along with vessel and acoustic source activity were recorded at least once an hour, or every time there was a change of one or more of the variables. Most observations were held from the tower; however, during severe weather or when the ships exhaust was blowing on the tower, observations would be conducted from the bridge (approximately 12.8 meters above sea level) or the catwalk (approximately 12.3 meters above sea level) around the bridge.

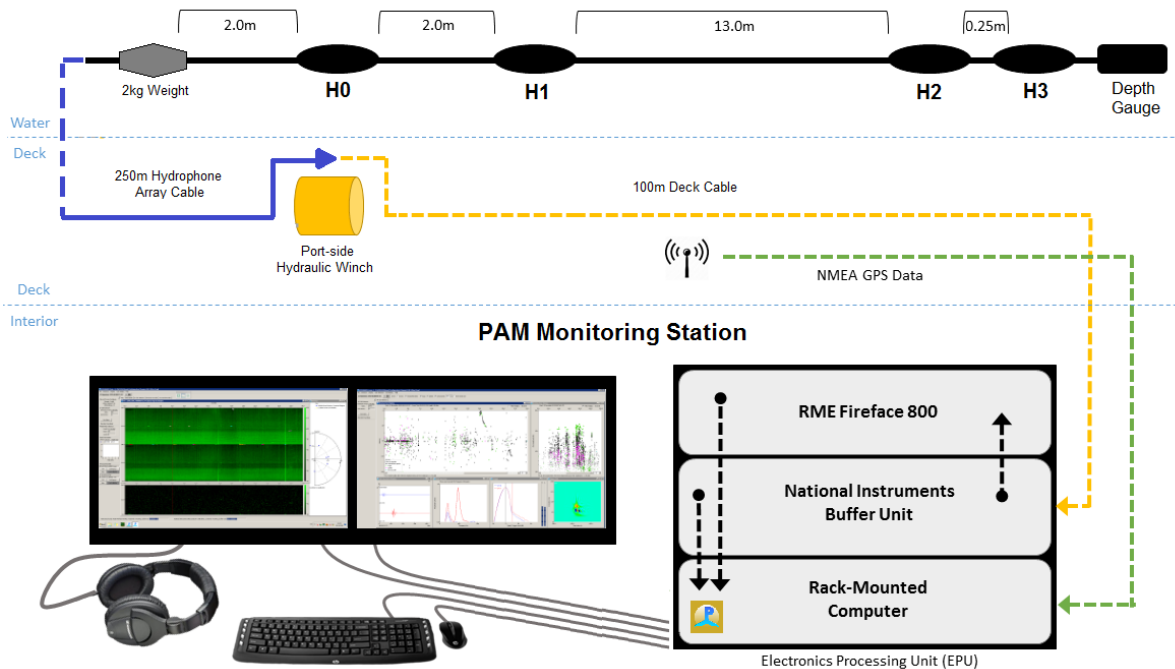
Figure 3: Simplified pathway of data through the PAM system on board the *Langseth*.

also present onboard in the event the main system components became damaged or inoperable. The diagram in Figure 3 is a simplified depiction of the PAM system installed on the *Langseth*, and further PAM system specifications can be found in Appendix C.

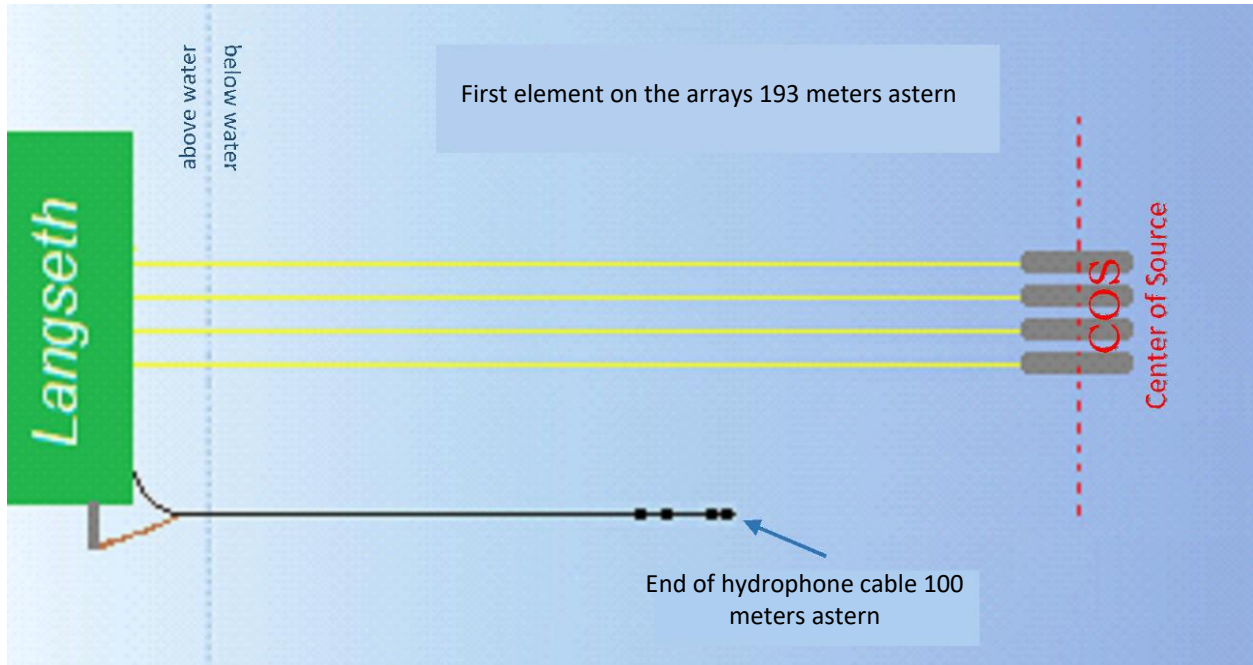
Figure 4. Location of the PAM cable in relation to the seismic gear during the survey program.

There were several adjustments to the deployment position of the PAM cable between 11 and 21 June 2019. Due to rough seas throughout the survey program, the hydrophone cable became entangled with the source array on three occasions. The deployment of the cable was adjusted between the port and starboard stern of the vessel on five occasions throughout the survey in order to prevent further entanglements with the seismic equipment.

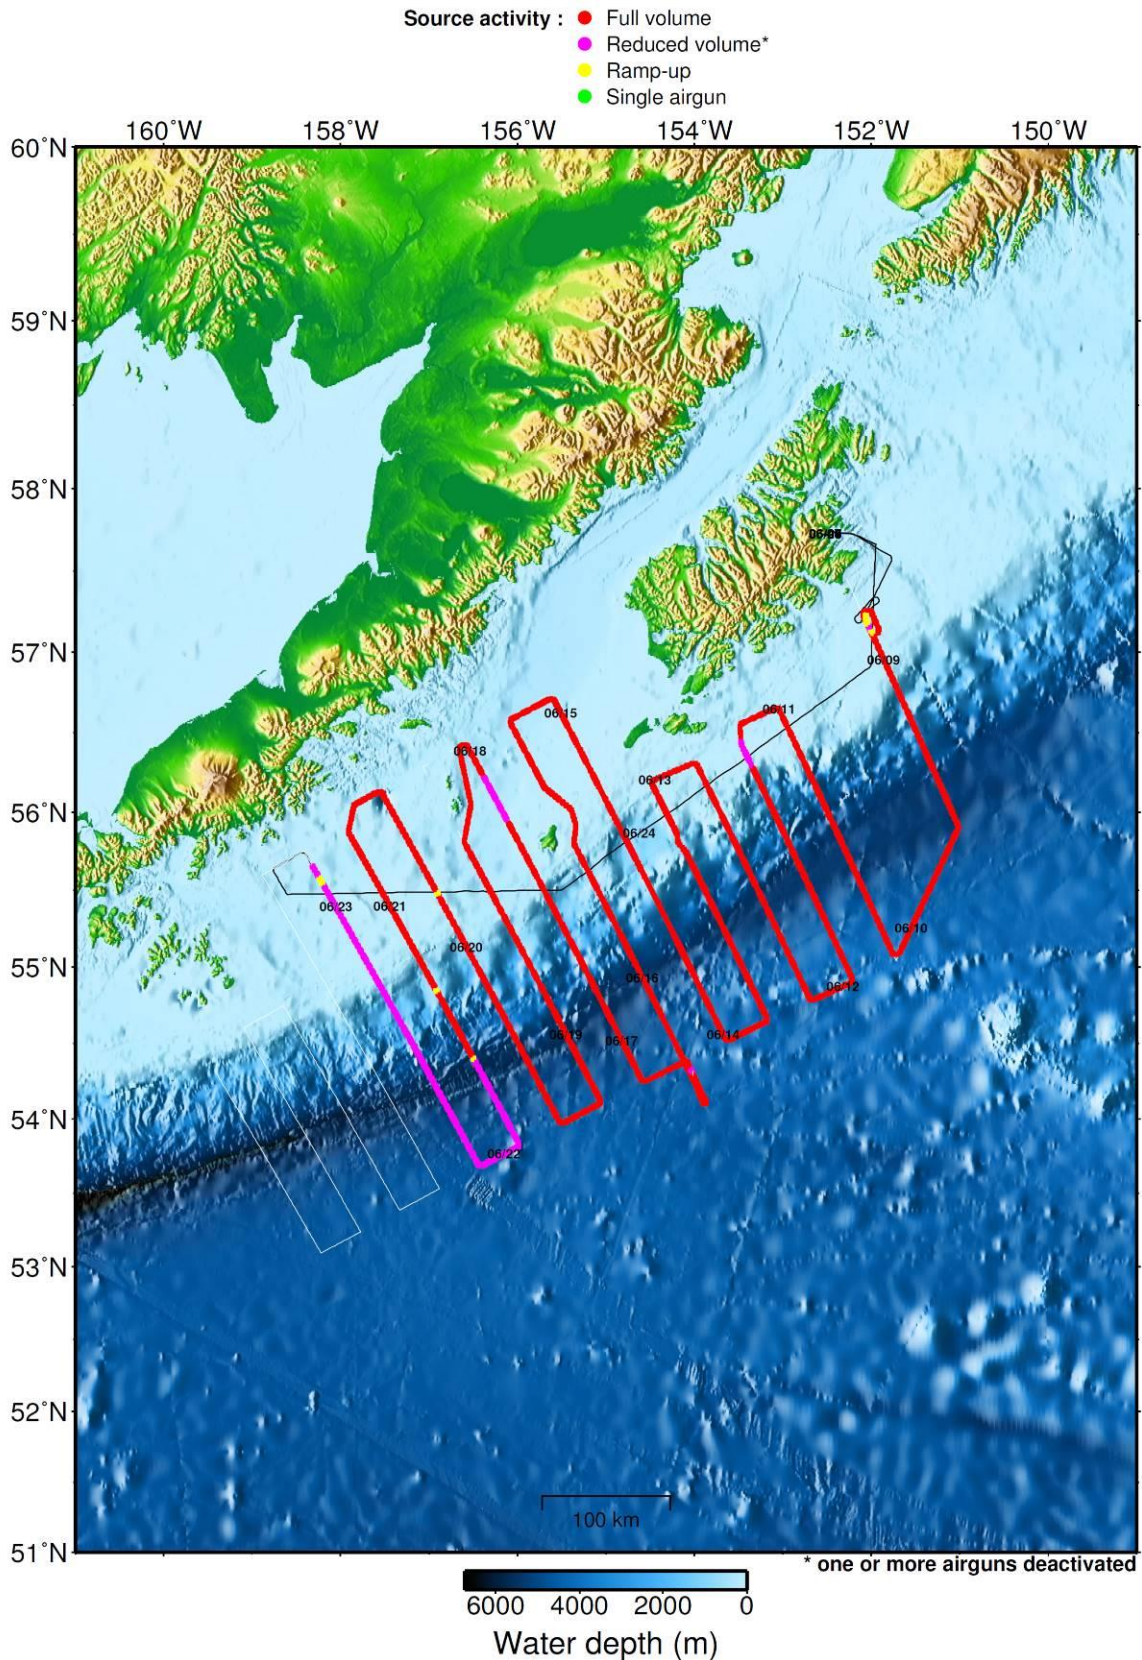
Figure 5: Geospatial data of source operations for the Gulf of Alaska survey area.

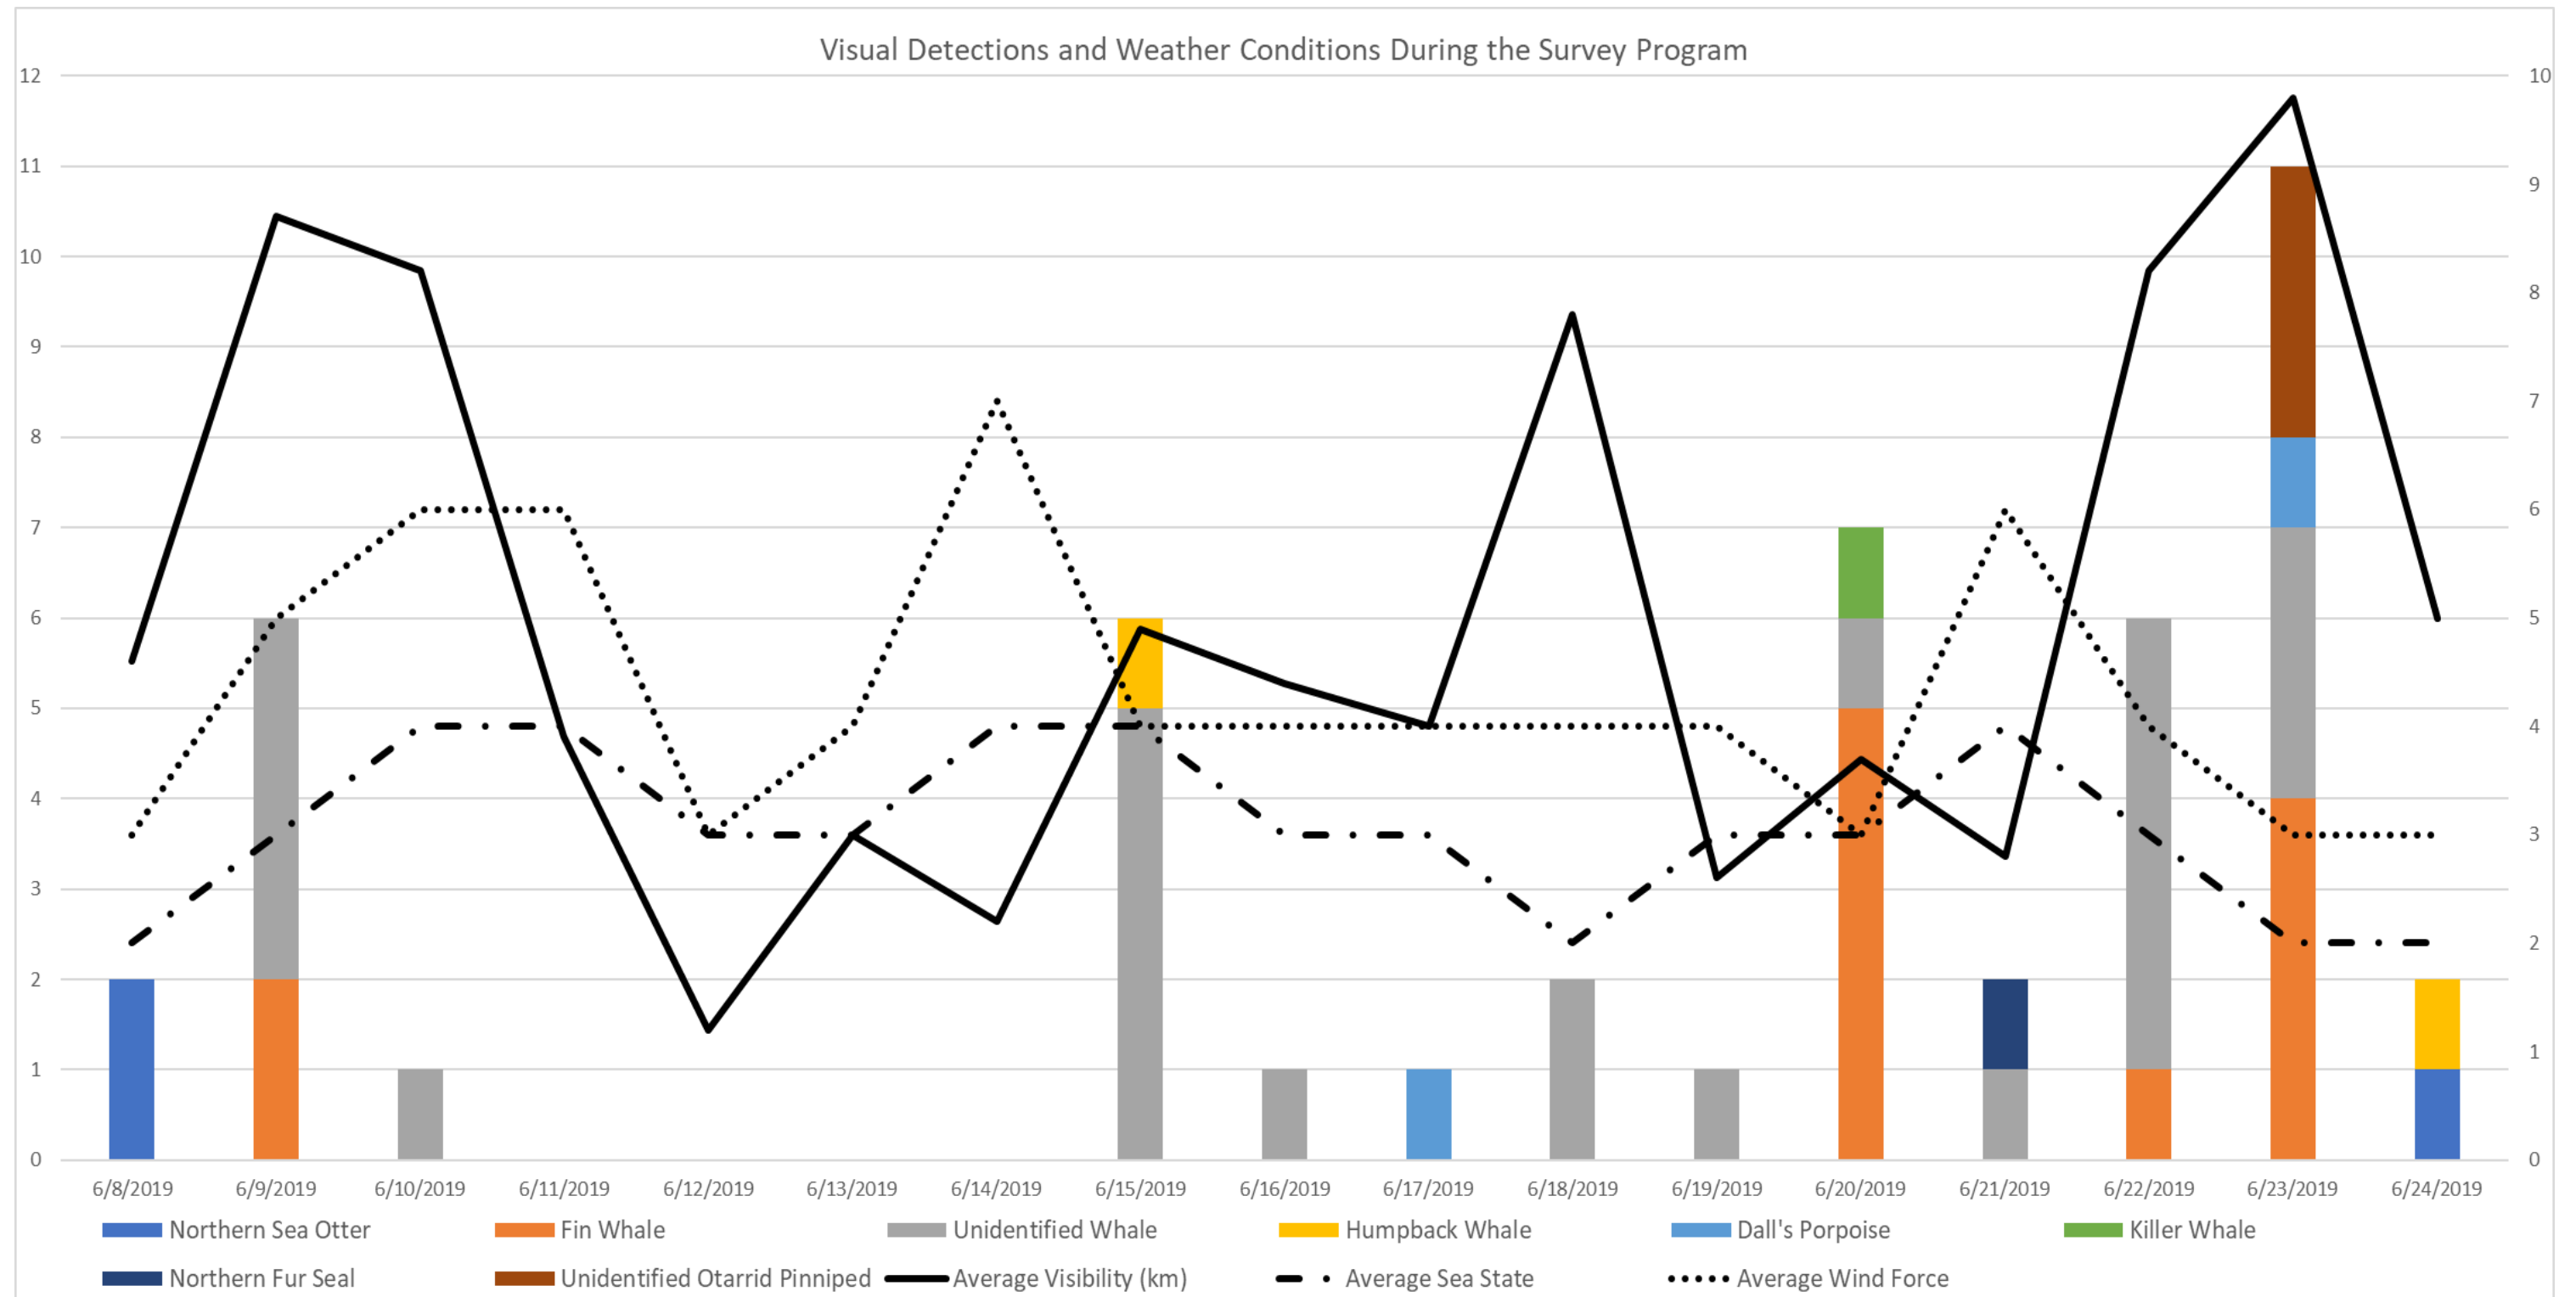
Figure 8: Number of protected species detections each day of the survey program and corresponding weather data for each day.

There was a large variability in weather conditions. However, in general, days with high numbers of visual detections corresponded with days with high visibility, small swells, and calm seas (Figure 8).

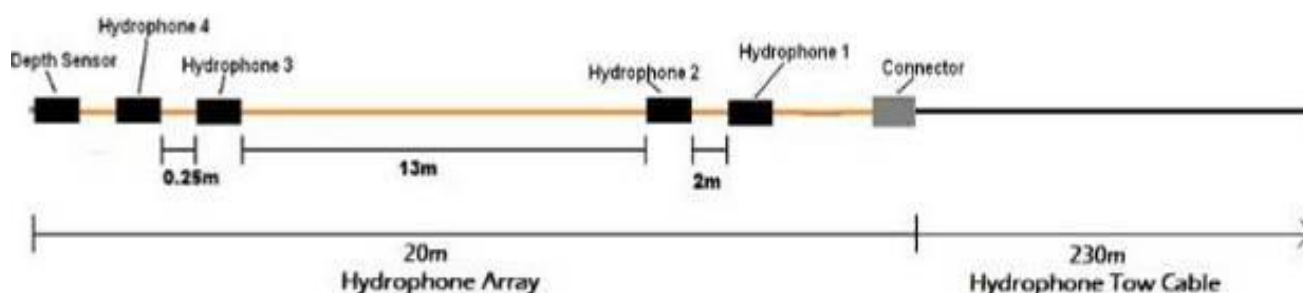
Figure 1: Two-part hydrophone cable with a 230-meter tow cable and detachable 20 meter hydrophone array

Two identical hydrophone cables were supplied for the Langseth consisting of a 230-meter steel reinforced tow cable with a detachable 20-meter hydrophone array. The arrays consist of two low-frequency hydrophones (200 Hz to 200 kHz), two high-frequency hydrophone elements (2 kHz to 200 kHz) and a depth gauge (100m capacity) potted directly into the cable. The four hydrophones have been positioned in two pairs, with the first pair positioned roughly 13m ahead of the second pair. A two-kilogram linked chain was taped onto the cable two meters forward of the innermost hydrophone element (Hyd 1) to aid in increasing the tow depth of the cable (Figure 1).

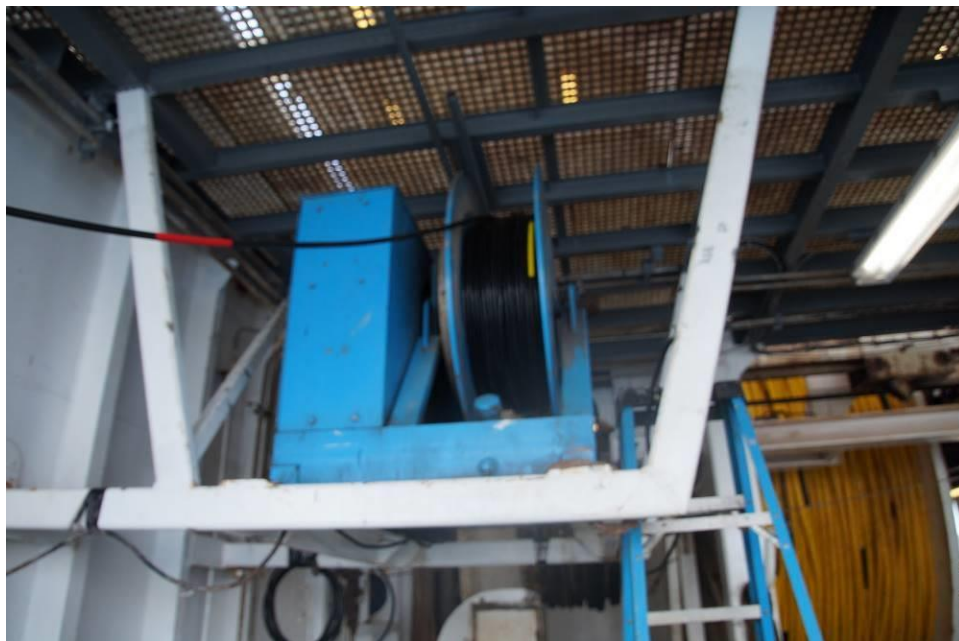
Figure 2: PAM cable spooled onto the winch.

The hydrophone cable was spooled onto a hydraulic winch located on the port side of the gun deck (Figure 2). A 100-meter deck cable connects the hydrophone cable on the gun deck to the PAM station in the main science lab (Figure 3). Due to the structural design of the vessel, two 100-meter deck cables were installed in port, prior to the project. One of the deck cables was designated as the main cable and the other acted as a spare. The main deck cable was connected to an electronic processing unit (EPU) located, along with two monitors and other monitoring equipment, at the PAM station in the main science lab (Figure 4). The rack-mounted EPU was secured in the event of rough weather. A GPS feed (GNGGA string) was supplied to the system by the ship's navigation Seapath 200.

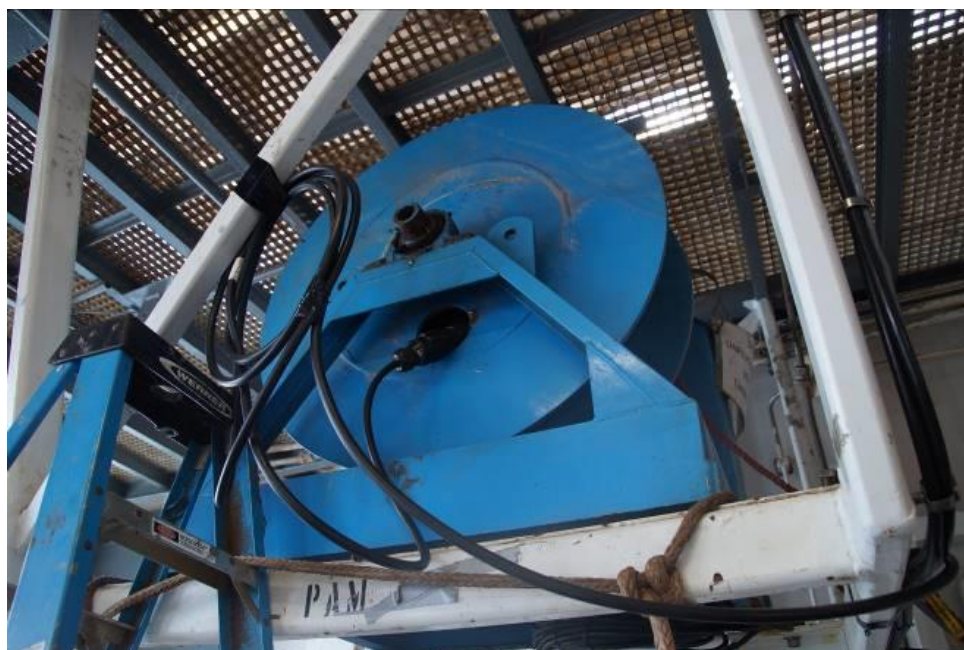
Figure 3: Hydrophone cable on the winch connected to the main deck cable.

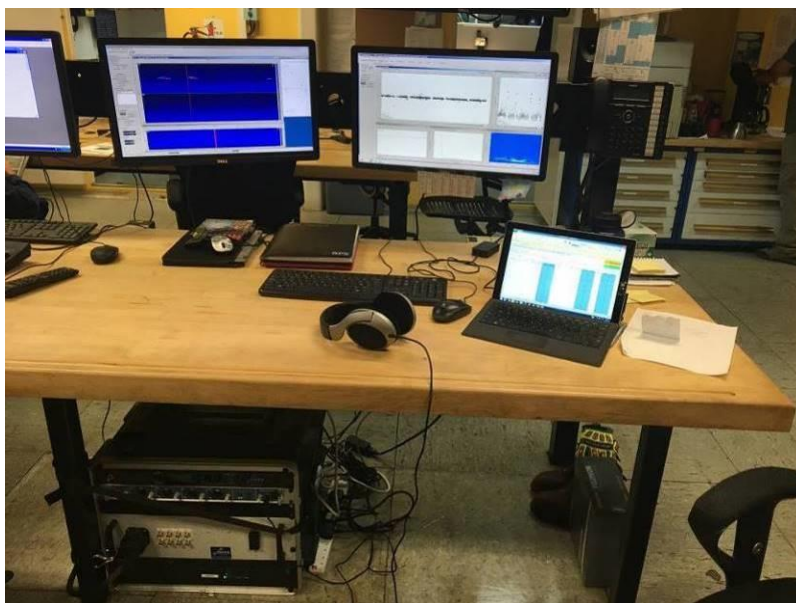
Figure 4: Passive Acoustic Monitoring Station in the Main Science Lab

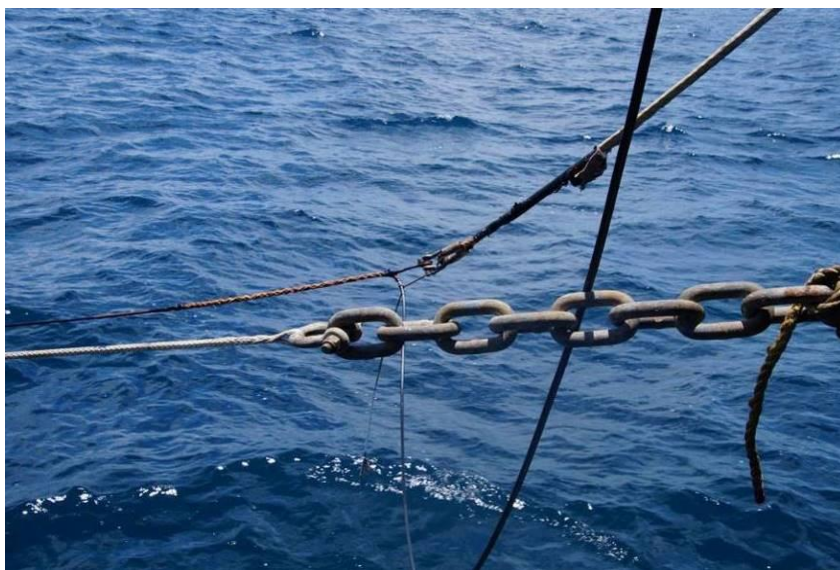
Figure 5: The PAM cable connecting to the offset rope via shackle.

The hydrophone cable was deployed directly off the stern of the vessel, just aft of the winch. To minimize the risk of entanglement with the seismic gear, the cable was attached, via a Yales grip, to a lifting rope, which offset the towing point of the cable approximately two meters to port (Figure 5). A Chinese finger was attached to the hydrophone cable as a tow point to reduce the tension on the cable that remained spooled on the winch when deployed. Approximately 100 meters of the hydrophone cable were towed astern of the vessel for the survey, which placed the end of the cable approximately 93 meters ahead of the acoustic source array.

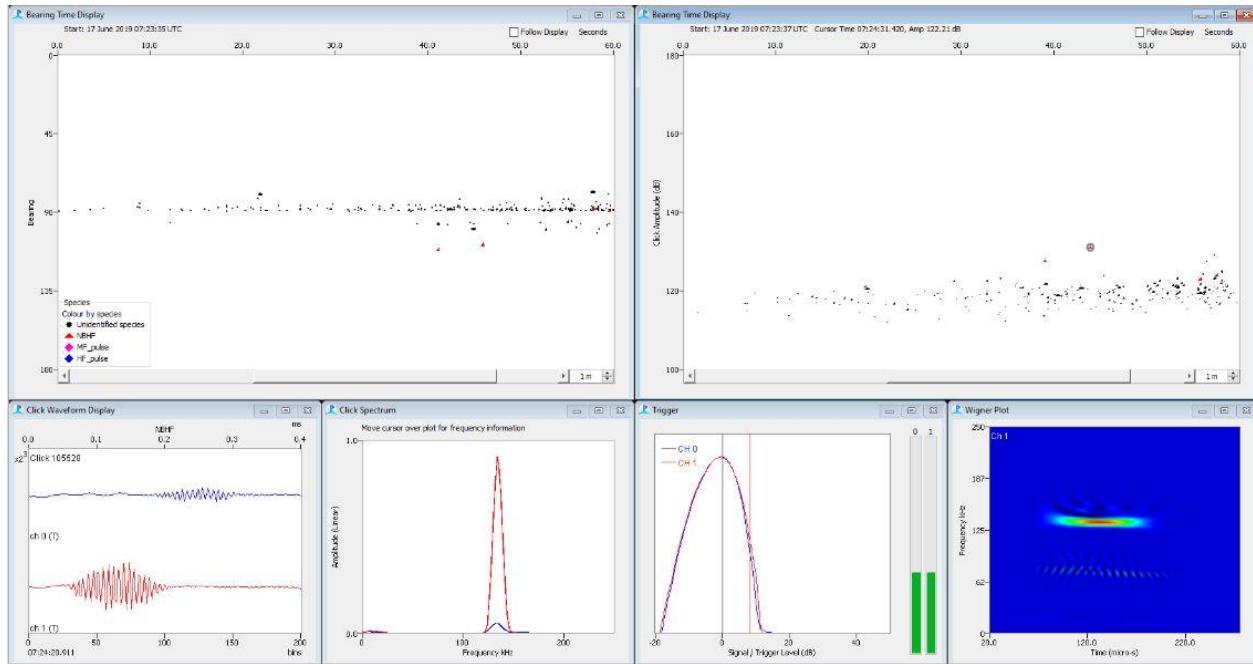
Figure 30: Acoustic detection #1; Dall's porpoise; 17 June 2019.

There was one acoustic detection of protected species. The detection consisted of Dall's porpoises, and was concurrent with a visual detection of the individuals. A summary of the acoustic detection details can be found in Appendix I, and screenshots taken of acoustic detection can be found in Appendix K.
