# REPORT OF THE SAFOD ENGINEERING SUBCOMMITTEE OF THE ADVISORY COMMITTEE FOR GEOSCIENCES, MARCH 30, 2011

## A. Introduction

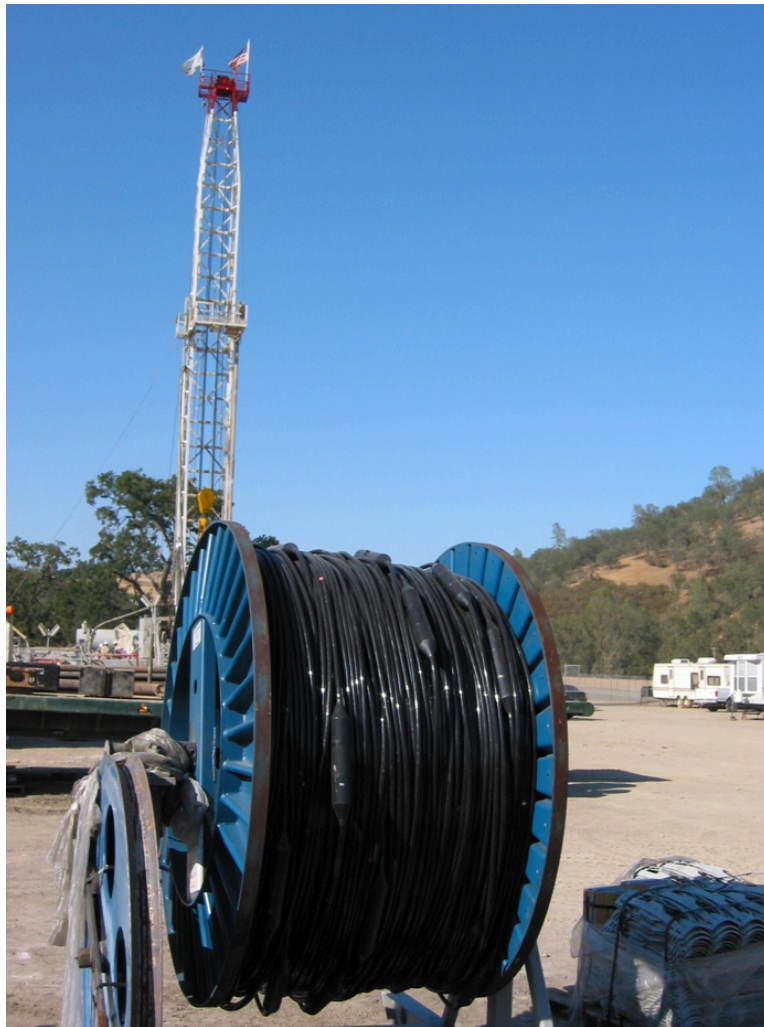
**Figure 5 Downhole 240 Channel 80 Level Geophone Array**

All of the MH001 to MH017 deployments were carried out on a standard wireline that was donated (used) by Oyo/Geospace, with the exception of deployments MH004 to MH006, which consisted of a passive 240 channel, 80 level, 3-component geophone array on a specialized cable (Figure 5) containing individual twisted conductor pairs. The array provided good data for low-amplitude signals. However, the clamping force was not sufficient to prevent crosstalk between the channels for higher-amplitude signals and the recording of target events.

exposed to the wellbore fluid (wet side) was filled with Krytox, a high-density oil that is used as a water block in high temperature geothermal cable heads. However, failure occurred as the Krytox either leaked out or was displaced by wellbore gas. The Kalrez O-rings showed no sign of damage, although the cable above the cable head was seriously corroded. A decision was made to try potting the wet side of the cable head with a different grease and better Kalrez O-rings, which were more resistant at high temperature. While marginally better, failures continued from MH012 to MH016 (October 24 to November 9, 2006). These short deployments were for the purpose of recording test shots. A test on January 11, 2007 (MH017) involved filling the cable head with high temperature epoxy. The two DS250s used in the test failed a week and a half later. Failure was attributed to poor bonding of the epoxy to the feed-thru in the cable head, allowing water to enter and create a short between conductors.

Lastly, in addition to the many cable head failures, the portion of the wireline above the cable head was also a source of problems during the 2006 to 2007 deployments. Corrosion and embrittlement of the copper conductors by fluid and gases occurred, which made them hard to work with when reheading the cable. This corrosion/embrittlement probably originated from leaks in the cable head, as water and gas traveled up the wireline, so that the cable head and wireline problems were probably related. Upwards of 7000 feet of wireline were removed during reheading operations in an attempt to get to undamaged cable.

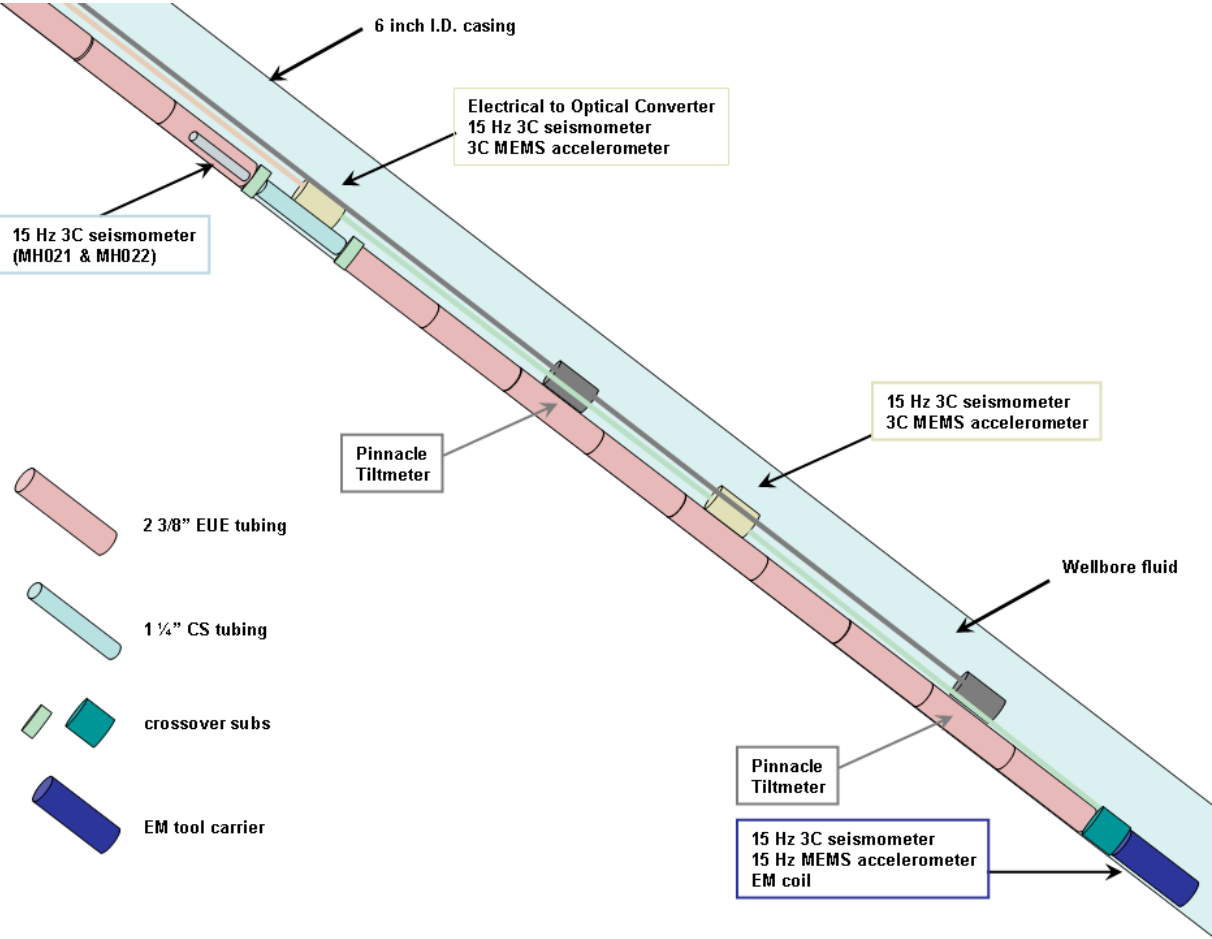
Figure 7 SAFOD Observatory Elements

- Splice S1 between Pod 3 and Pod 1 contained oil but not an aqueous phase according to conductivity measurements by Dr. Stringfellow. However, small amounts of water can dissolve in oil.

- Most instrument circuit boards and many electronic components showed signs of corrosion, and occasionally minor traces of oil, suggesting the breakdown of seals.

- A broken wire was found in Splice S2 (see Figure 3). It is not clear if the break occurred before or during disassembly.
