Arecibo Observatory William E. Gordon Radio Telescope (305-Meter Radio Telescope) Collapse Emergency Cleanup Update

December 2021

June to December 2021

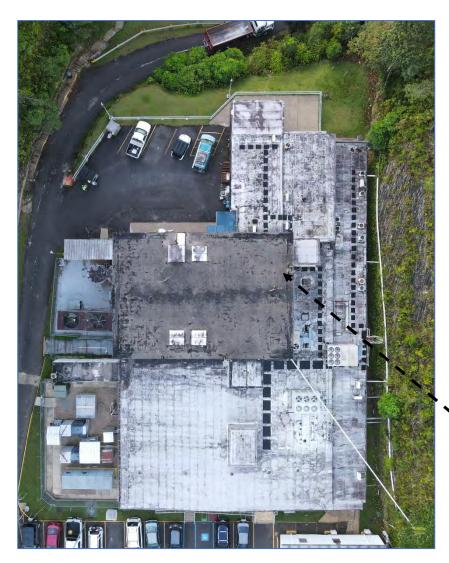
Operations Building (Building 1) *After Minor Roof Damage*

No changes or updates since last meeting. Minor roof damage was previously discussed.

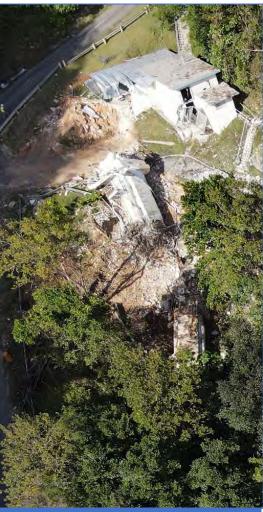
Cable Car Building (Building 5) *After* Damaged material removed from retaining wall and temporary concrete blocks installed since last meeting. Removal of front awning (nonsignificant element) was previously discussed. Blocks to temporarily remain in place.

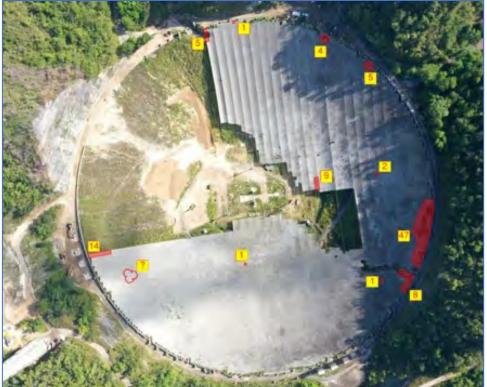
Reflector Area after collapse (left) and during clean-up (bottom right). Additional panels identified indicated in red with panel amount noted. Example of damaged panels (top right). Cleanup identified additional damaged panels that required mapping and removal. Reflector area damage was previously discussed.
